## North Coast Regional Water Quality Control Board

### Inspection Report

**Site:** Joseph Stafslie  
**CIWQS Place ID:** 842383 and 842382  
**Inspection Date:** May 23, 2019

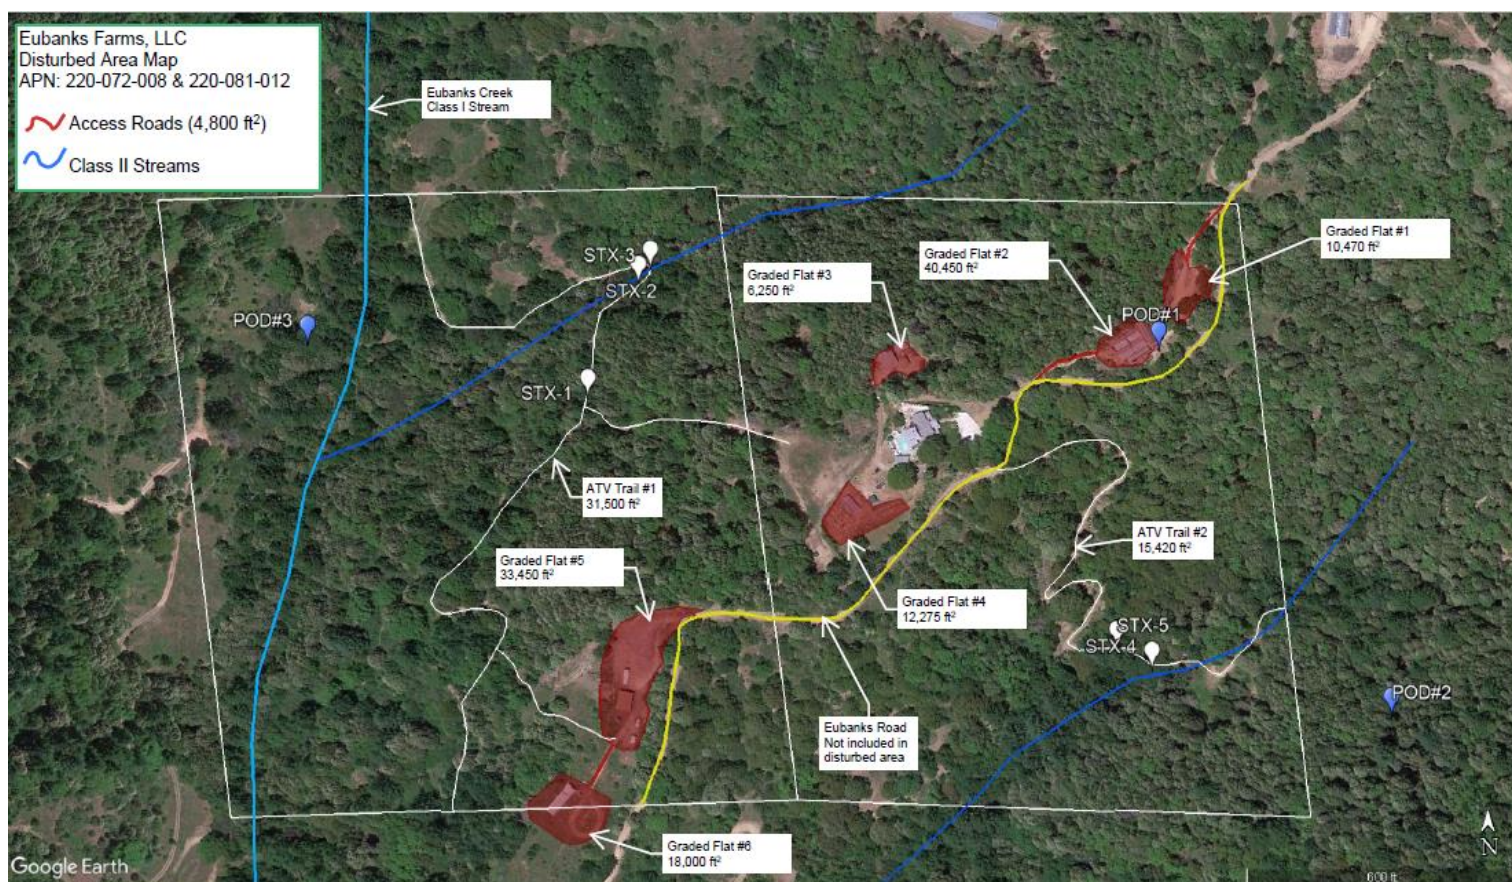
Figure 2 – Disturbed Area Map from *Eubanks Farm #2 SMP, NMP & Maps*

Graded Flat #1, Graded Flat #2, POD #1 in Figure 2 – I observed a well, dozens of water storage tanks, and multiple hoop houses with active cannabis cultivation on graded flats (photo 1). I did not observe erosion or irrigation runoff issues on the flats.

STX 1 in Figure 2 – I observed a culvert stream crossing occluded with sediment and with an outlet perched above the watercourse (photo 2). Replacement to an 18-inch diameter culvert or rocked ford is prescribed in the Site Management Plan (SMP).

STX 2 in Figure 2 – I observed a dirt ford stream crossing (photo 3). The watercourse was eroding the trail material and conveying it downstream to STX 3. Replacement to an 18-inch diameter culvert or rocked ford is prescribed in the SMP.

STX 3 in Figure 2 – I observed a 36-inch diameter culvert stream crossing with an outlet perched above the watercourse (photo 4). Replacement to a 42-inch diameter culvert or rocked ford is prescribed in the SMP. I measured an active channel width of 48 inches. I observed road runoff and stream water diverted from the failed STX 2 had channelized down the road and was actively eroding the fill around culvert STX 3, contributing sediment to the watercourse (photo 5).

POD #3 in Figure 2 – I observed an intake line with a screen in the pool of a watercourse (photo 6). Directly downstream I observed a settling barrel (photo 7). We discussed in the field moving water diversion infrastructure out of the watercourse to the extent possible.

ATV Trail #2 in Figure 2 – I observed the end of ATV Trail #2 that is being decommissioned. The trail was covered in straw and vegetation was reemerging (photo 9). Outsloping and adding drainage relief are prescribed in the SMP.

STX 5 in Figure 2 – I observed a culvert stream crossing with a buried outlet (photo 10). Culvert removal and excavation to natural channel gradient is prescribed in the SMP.

STX 4 in Figure 2 – I observed a 36-inch diameter culvert with an outlet perched above the watercourse (photo 11). Because the culvert was not aligned with the watercourse, the channel bed at the base of the outlet is eroding and transporting sediment downstream. Culvert removal and excavation to natural channel gradient is prescribed in the SMP.

POD #2 in Figure 2 – I observed an intake line with a screen in the pool of a watercourse (photo 12). Directly downstream I observed a settling barrel (photo 13). We discussed in the field moving water diversion infrastructure out of the watercourse to the extent possible. I recorded this point on the eastern parcel boundary, which differs from its location in Figure 2.
